COUNTY OF MILWAUKEE
Behavioral Health Division Administration
INTER-OFFICE COMMUNICATION

SUBJECT: **From the Director Department of Health and Human Services, providing an informational report regarding the Department's intent to close the Behavioral Health Division Center for Independence and Development (formerly Hilltop) and Rehabilitation Center Central and to relocate residents to integrated community settings – A Mental Health Redesign Effort**

CBRE

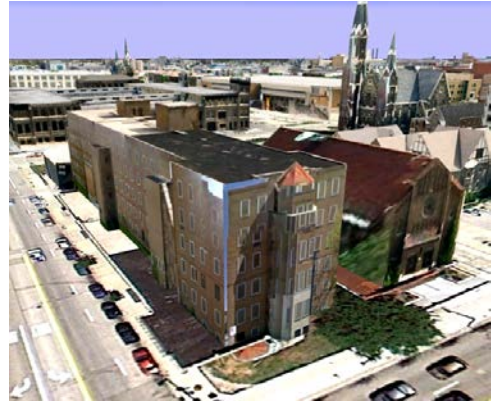
Community Correction Center

- Background Data
 - Square Feet: 75,544
 - Year Built: 1930's
- Overall Building Condition
 - Currently boarded up and not used
 - Crumbling concrete, rusted exterior railings and miscellaneous metal

- Summary
 - The existing building should be demolished
 - The remaining vacant parcel may be used for parking, court consolidation or related County functions or it could be sold. We recommend holding until details of Core Campus plan are finalized.

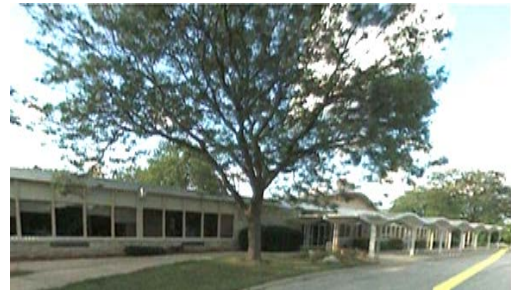
Washington Park Senior Center

- **Background Data**
 - Square Feet: 30,092
 - Year Built:
- **Overall Building Condition**
 - Overall the building is in good condition
 - Many systems while functional are nearing the end of their useful life
- **Functionality/ Utilization**
 - Some restrooms are not ADA compliant
 - Adequately serves the senior center function
- **Operational Issues**
 - Many systems while operational are nearing the end of their useful life
- **Major Capital Requirements**
 - Primarily to upgrade systems
 - Exterior maintenance issues include walkways, front entrance, leaking roof and tuckpointing

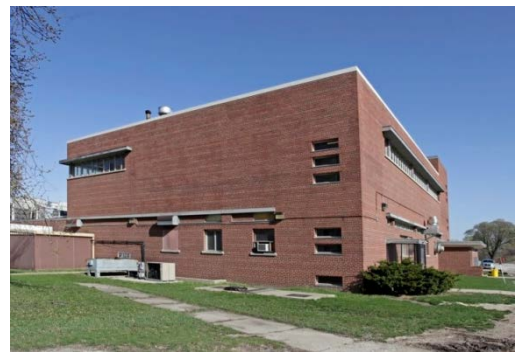
Food Service Building

- Background Data
 - Square Feet: 35,028
 - Year Built: 1957
- Overall Building Condition
 - Overall the building has many features and systems that are from the original construction
 - Many systems should be replaced
- Functionality/ Utilization
 - Kitchen dry food storage is on the second floor which creates kitchen inefficiencies
- Operational Issues
 - The facility is oversized for the current usage which has fallen with smaller patient loads at the mental health facilities
 - The building is not air conditioned

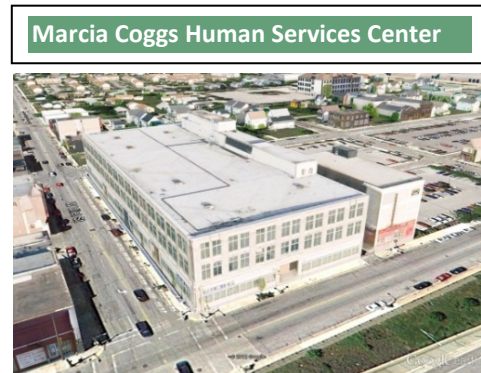
- Loading dock requires protective guardrails
- Open water service well in basement should have cover
- Neighborhood security is an issue

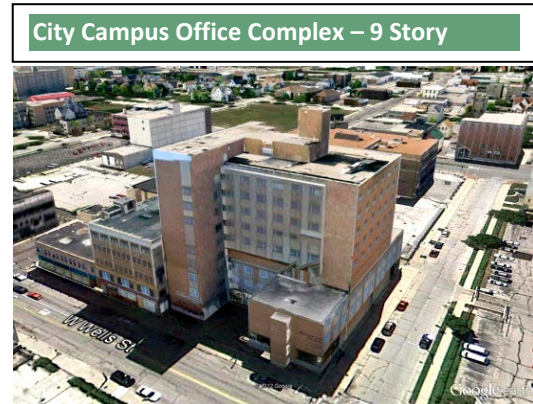
- Background Data
 - Square Feet: 129,989
 - Year Built: 1986
- Overall Building Condition
 - Overall building conditions are fair
- Functionality/ Utilization
 - The former hospital layout does not function well for office use
- Operational Issues
 - Very high cost to operate the building
- Major Capital Requirements
 - Extensive infrastructure upgrades are going to be required
- Safety
 - Sixth floor, which is used for storage, is not safe
 - Major deficiencies in fire protection system
 - Building lacks selected fire rated doors, dampers and penetration seals
- Highest & Best Use
 - Alternative redevelopment of the site tailored to the City of Milwaukee - Near West plan
- Summary
 - Demolish and sell

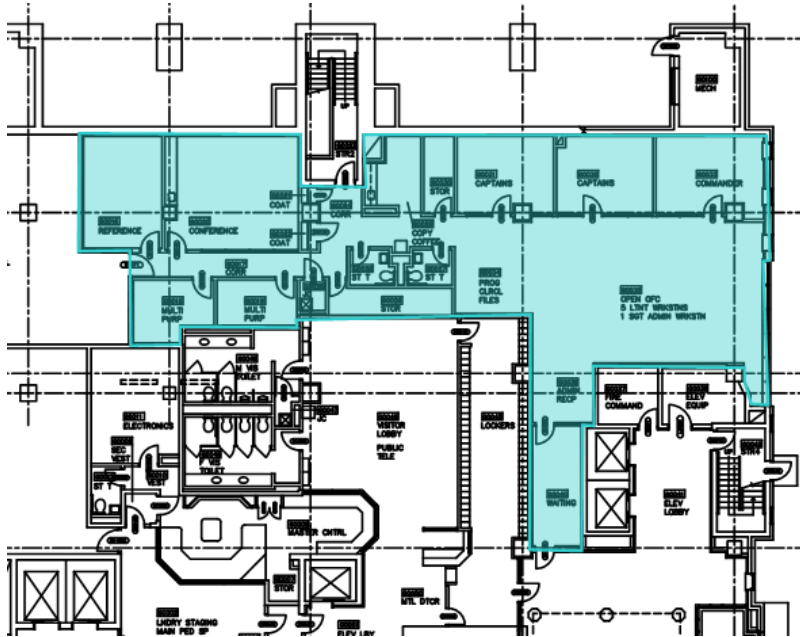
- Suite L01 Administrative Offices (color coded blue) appears to be under renovation and is largely unoccupied except for a receptionist and 2 enclosed offices.

- It is apparent that general maintenance of equipment and certain finishes have not been routinely replaced or upgraded since the building was built. In talking with maintenance staff there is no running list or check-off of maintenance items that they track for record purposes. Maintenance seems to be reactive instead of proactive.
- Ceiling tiles have been routinely replaced due to leaking valves, dripping pipes, etc. due to lack of maintenance. There is an abundance of ceiling tile stored in the basement for this purpose.
- Exterior precast panel joints require tuck-pointing and sealant. The sealant used at the time of construction in 1992 is approaching its expected life and is very important to maintain since this is the only barrier at the joint to keep the building weather tight.
